# Cooling Tower protected thanks to Belzona

Industry: *Sugar*  
Application: *TCC-Tanks and Chemical Containment Areas*  
Substrate: *Concrete*  
Products: *\* Belzona 4111 (Magma Quartz) ,  
\* Belzona 5811 (Immersion Grade) ,*

Customer Location: *Sugar Mill, France*  
Application Date: *July 2018*

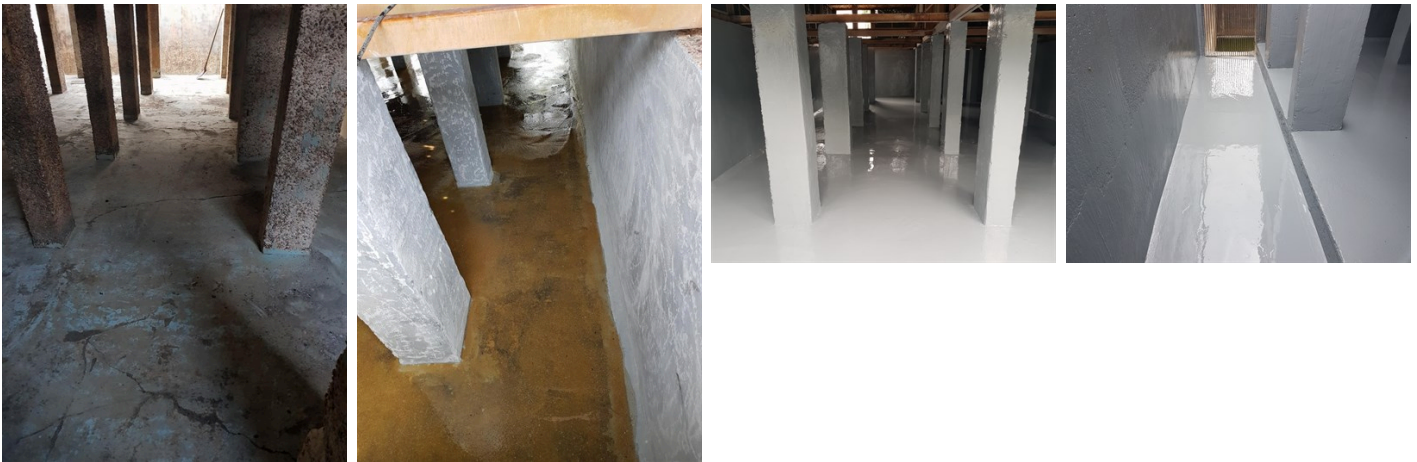
*General corrosion of the concrete basin*

- \* 1- Corrosion of the concrete and exposed steel re-bar ,
- \* 2- Repair of the concrete work using Belzona 4111 ,
- \* 3- Work completed with application of belzona 5811 ,
- \* 4- Work completed ,

Application was carried out in accordance with Belzona Know-How System Leaflet TCC-15.

Belzona 4111 and 5811 are ideally suited for the long term protection of cooling water basins given their high adhesion values and excellent corrosion resistance and performance in immersion up to 50°C.
