Belzona puts Screw Conveyor Back in action

Industry: Sugar

Application: SHM-Solids Handling Machinery

Customer Location: Sugar Mill, France

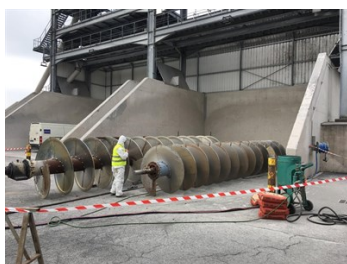
- * 1 - Screw Conveyor ,
- * 2 - Extend of the pitting ,
- * 3 - Rebuilding of the pitted areas ,
- * 4 - Belzona 1331 applied as a protective coating ,

Screw conveyor, displacing sugar beets

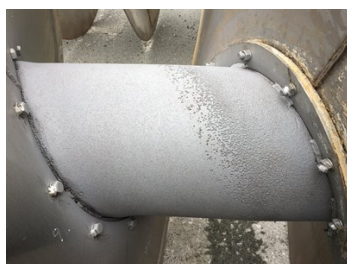
Erosion/corrosion caused pitting damage on the screw conveyor surface. Damage due to the beets as well as rocks and gravels.
