Belzona provides a second life to this cooling tower

Heat Exchanger - acid cooling tower. Operating pressure of 1 bar and temperature between 30 and 50C.

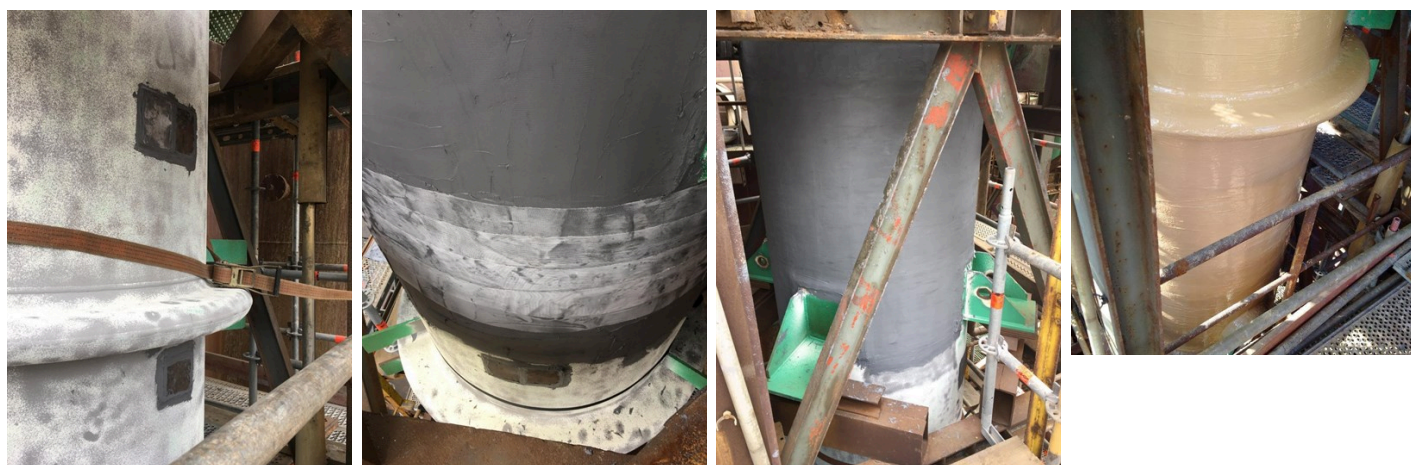
Photograph Descriptions

External corrosion leading to significant wall thinning and localised through wall defects.

- * 1 - The cold bonding of metal plate to patch up thin areas ,
- * 2 - Wrap in progress ,
- * 3 - Wrap completed ,
- * 4 - Coating for further corrosion protection ,

Application was carried out in accordance with Belzona Know-How System Leaflet TCC-5.

Two towers were suffering from the same problem at the same time: through wall defects due to corrosion. The customer had one

spare ready (costing 90,000€) but could not afford to wait for a replacement one being given the 8 months lead time. The Belzona repair was completed in 4 days by a team of 3 technicians. The tower was put back in service within 72 hours. The Belzona repair (products + application) did cost one-third of the replacement cost (30,000€).
