Belzona top up after 3 years service

ID: 7743

Industry: Power
 Application: CEP-Centrifugal Pumps
 Substrate: Carbon Steel
 Products: * Belzona 1121 (Super XL Metal) ,
 * Belzona 1341 (Supermetalgilde) ,

Customer Location: Italy
 Application Date: 2015 (re-coated 2018)

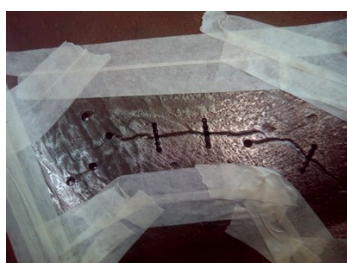
Impingement erosion coupled with corrosion from the contaminated water had caused significant metal loss to various areas of the pump housing. Damage was most noticeable around the flow straighteners, where turbulent flow had increased the rate of erosion.

- * 1. Erosion / Corrosion damage ,
- * 2. Crack ends drill tapped and terminated by metal stitching ,
- * 3. Repair and coating application complete ,
- * 4. Re-coated after 3 years in service ,

The cost of replacement for the pump casing significantly outweighs using a coating as a sacrificial measure to be maintained/re-coated every 3-4 years. Belzona was selected for this application as alternative rebuild methods were unable to repair and terminate the cracked areas of the casing. The efficiency enhancement of the Belzona 1341 (Supermetalgilde) introduced an additional cost benefit for the customer by reducing energy consumption of the pump. The pump was inspected 3 years into service and 80% of the coating was still in very good condition. The coating was refurbished before being put back into service.
