Belzona protects steel joints on large suspension bridge

ID: 7745

Customer Location: Greece
Application Date: July 2018

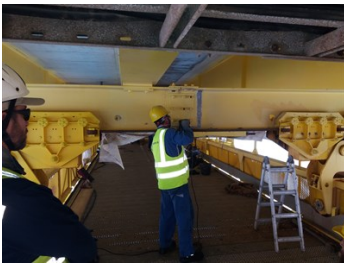
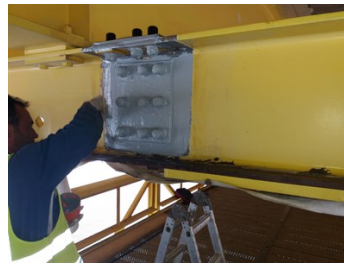
Corrosion in the bolt areas of the steel joints caused by insufficient protection from the existing paint. Due to the movement in the joints, the customer required a flexible coating. They wanted a system that would allow them to later inspect the bolts.

* 1. Preparation being carried out
2. Preparation completed
3. First coat of Belzona 3412 applied
4. Completed application ,

The existing paint was insufficient to protect the joint areas as it didn't have the edge retention to get good coverage of the complex geometry in this area. Due to the movement in the substrate, traditional protection systems were not suitable as these may crack in service. An added benefit for the customer is the ability to inspect the bolts at a later date easily.
