Belzona protects steel joints on large suspension bridge

ID: 7745

Industry: *Buildings & Structures*
Application: *GSS-Gaskets, Seals and Shims*
Substrate: *Steel*
Products: ** Belzona 8411 ,*
** Belzona 3412 ,*

Customer Location: *Greece*
Application Date: *July 2018*

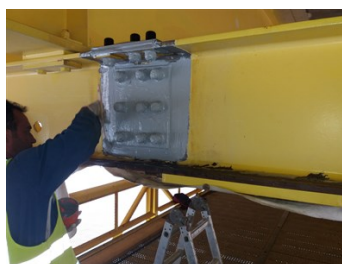
Corrosion in the bolt areas of the steel joints caused by insufficient protection from the existing paint. Due to the movement in the joints, the customer required a flexible coating. They wanted a system that would allow them to later inspect the bolts.

* 1. Preparation being carried out
2. Preparation completed
3. First coat of Belzona 3412 applied
4. Completed application ,

The existing paint was insufficient to protect the joint areas as it didn't have the edge retention to get good coverage of the complex geometry in this area. Due to the movement in the substrate, traditional protection systems were not suitable as these may crack in service. An added benefit for the customer is the ability to inspect the bolts at a later date easily.

Application was carried out in accordance with an amended version of System Leaflet GSS-11.
