# Belzona Helps Rebuild End Cooler Headers

ID: 7746

End cooler headers of a tube sheet. Design temperature: 200F

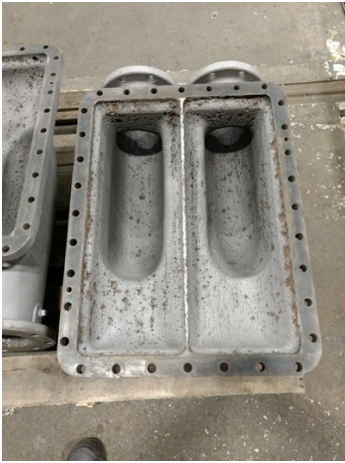
Severe pitting, corrosion appeared on the covers after years of operation. The worst of the pitting was about 8mm deep

- \* 1. Internal surface before application ,
- \* 2. Internal surface showing severe pitting & corrosion damage ,
- \* 3. Belzona 1511 application, the product is being applied ,
- \* 4. Completed application ,
