# A SHOWER AT A MINE MADE SAFE WITH BELZONA

ID: 7756

**Industry:** Mining & Quarrying  
**Application:** FPA-Floor Problem Areas  
**Substrate:** Concrete  
**Products:** \* Belzona 4911 (Magma TX Conditioner) ,  
\* Belzona 4111 (Magma-Quartz) ,  
\* Belzona 5911 (Ceramic Conditioner) ,  
\* Belzona 5111 (Ceramic Cladding) ,

**Customer Location:** Alaska, USA  
**Application Date:** March 2018

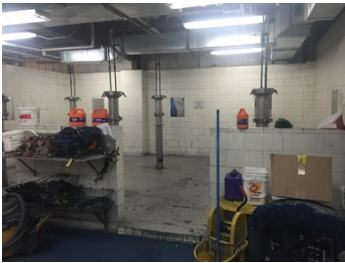
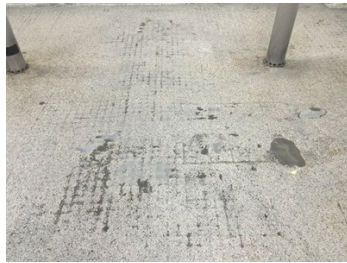
Originally, the floor was tiled. Eventually, it was damaged and an epoxy coating was used. It did not last too long before it began to flake off.

- \* 1. Shower in original condition. ,
- \* 2. Shower in original condition. ,
- \* 3. Application is complete. ,
- \* 4. Application is complete. ,

The application was carried out in accordance with a modified version of FPA-1 System Leaflet. The entire floor was prepped with a concrete grinder. The existing epoxy was removed, and the surface of the concrete was smoothed off leaving clean fresh concrete. Belzona 4911 and 4111 were applied over the entire floor to smooth off the irregularities and fill in the damage that was present from where the grout lines were with the original tile. Once that was completed, Belzona 5911 was applied with a semi-fine

alumina oxide aggregate to provide a safe slip-free floor. Following the Manufacturer's Instructions For Use, Belzona 5111 was applied in two coats, first white, then gray as the Customer chose.
