# BELZONA REPAIRS AND PROTECTS GAS STATION CONCRETE FLOOR

ID: 7761

Industry: Buildings & Structures  
Application: FPA-Floor Problem Areas  
Substrate: Concrete  
Products: \* Belzona 4151 (Magma-Quartz Resin) Belzona 5811 (immersion grade) ,

Customer Location: France  
Application Date: July 2018

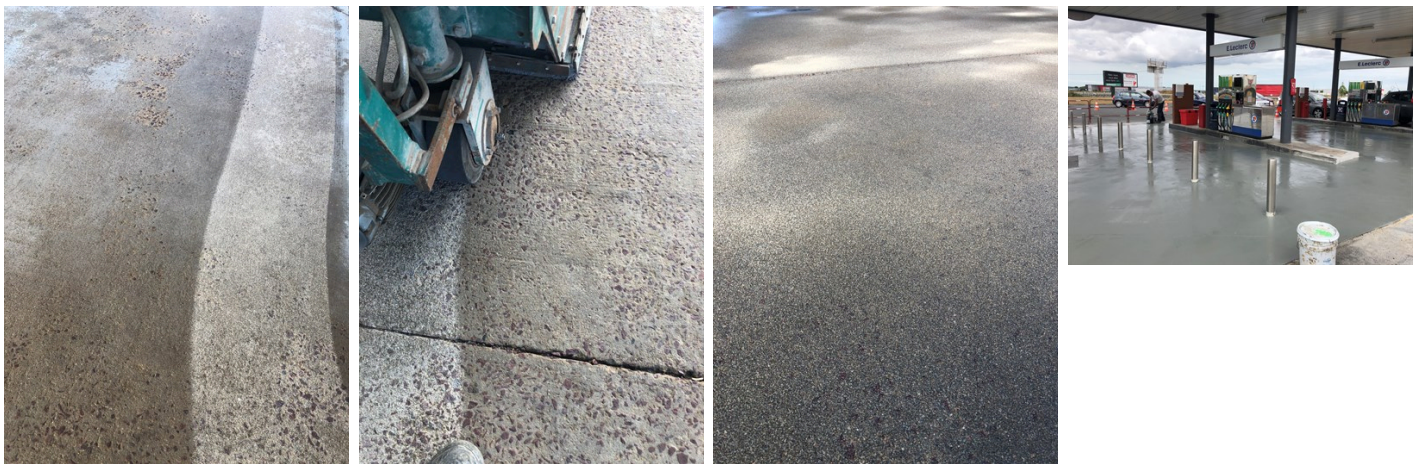
\* 1- Damaged and slippery concrete 2- Grit blasted concrete 3- Resurfaced concrete with silica 4- Final result with Belzona 5811 ,

The concrete floor of this gas station was damaged, greasy and slippery.

The floor was steam cleaned the grit blasted. The concrete has then been resurfaced with Belzona 4151 and covered with Silica 0.5-1.25 using Belzona Know-How system leaflet FPA-8. 4 hours later, Belzona 5811 was applied on top of the silica to complete the non-slip system and protect the surface from hydrocarbons.
