Expansion joint rebuild done right with Belzona

ID: 7763

Hospital construction joint.

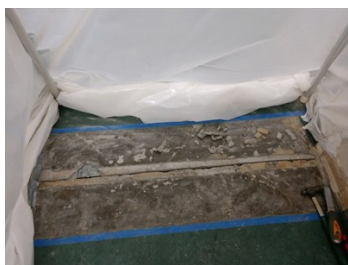
This was a construction joint from when the hospital was expanded. No expansion joint was installed, it was just concrete against concrete. Over the years the expansion and contraction caused the concrete at the seam to break and crumble. The metal and rubber expansion joint strip mounted over it also caused a bump in the floor.

- * 1. VCT tiles removed and damaged concrete being removed. Notice the large area broken out on the left side. ,
- * 2. Applying the Belzona 4111 on either side of the former. ,
- * 3. Ready to pour the Belzona 2221, waiting for the Belzona 2911 to cure. ,
- * 4. Tape removed. Completed successful application. ,

The original VCT flooring tiles were removed from either side of the seam. The loose and broken concrete was removed. The remaining concrete was ground back to open up space between the two sides. Belzona 4911 and 4111 were applied with the use of a plastic wrapped former to leave a nice squared, even area for the expansion joint to be created. The new full sheet vinyl flooring
