# Belzona repairs leaky pipes from a heat exchanger

Application: *HEX-Heat Exchangers*

Customer Location: *France*

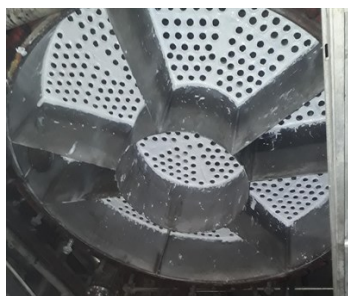
*Sealing problem between the tubes and the tubular sheet on these heat exchangers due to a bad tube expansion, 50% of the tubes were leaking.*

\* 1- View of the equipment before application 2- Final application ,

The tubular sheet and the tube ends were grit blasted and cleaned with Belzona 9111 (Cleaner Degreaser) . Belzona 1111 (Super Metal) was used to rebuild the profile between the tubes and substrate then Belzona 5892 was applied on top for further protection against aqueous solutions. The application was carried out in accordance with a modified version of HEX-1 followed by HEX-3 Belzona System Leaflet
