# Belzona Rebuilds 112 Year-Old Yacht Hull

ID: 7770

Hull rebuilding on a 112 year old boat.

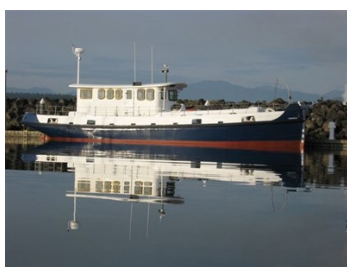
- \* 1. The Sarah Elizabeth Banks, formerly the SS Fire King ,
- \* 2. In dry dock, ready for repairs. ,
- \* 3. Port side hull application complete. ,
- \* 4. Port side propulsion area application complete. ,

The hull coating was removed and the application areas were grit blasted. The areas were then treated with Salt-Away to remove the impregnated salt from 112 years of sitting in saltwater. The areas were then blasted once again just prior to the application. Belzona 1151 Smoothing metal was mixed in several batches as there was one large area, and several smaller, detailed areas to work on. The Belzona 1151 was completely hand applied and finished using a Belzona applicator and a 10" steel putty knife. The Belzona 1151 was allowed to cure, and then over coated along with the rest of the hull with a standard hull coating anti-fouling material.

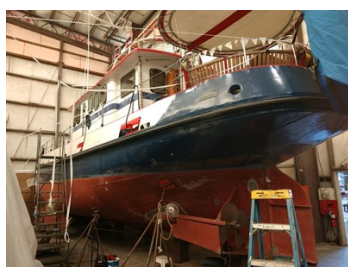
Several areas on the hull were corroding and getting thin. The front port side was thinning from wet/dry action due to being tied to a dock for a couple decades. The port side propulsion area was suffering from minor cavitation and erosion in the seam areas of the original riveted hull which had been filled with lead.
