Belzona protects the inside of hot liquor tanks in a brewery

ID: 7771

Customer Location: Tadcaster, UK
Application Date: 2018

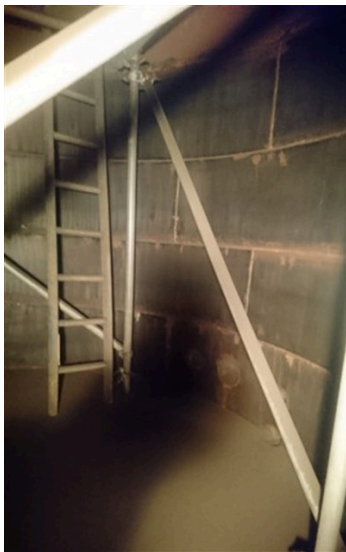
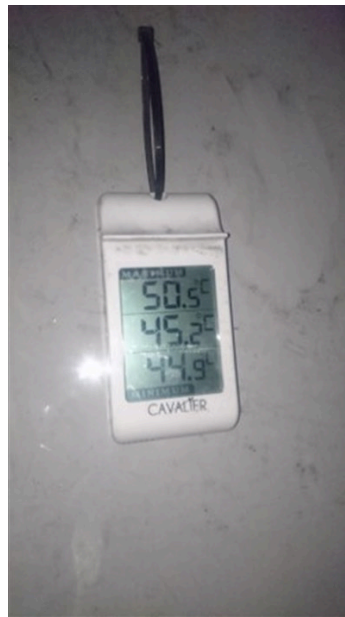
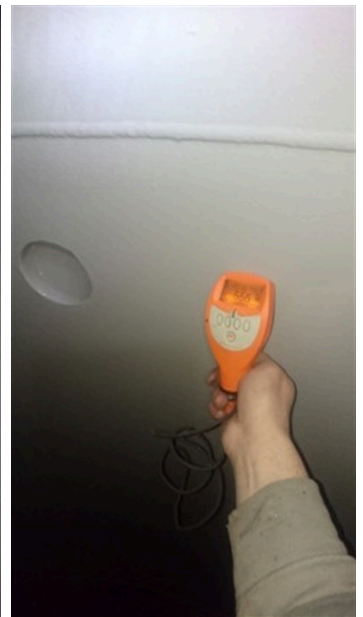
Photograph Descriptions

This brewery has 6 liquor tanks which operate at 85°C, they were all coated with an unknown liner which was failing. The location of the tanks meant that the client could not replace them and a high performance coating was required. The protective coating also had to have a potable water approval.

* 1- Blasted tank before application 2- Pit holes on the inside of the tank 3- Conditions inside the tank 4- Final application ,

The previous liner was removed by grit blasting, this step took 3 days. Once the pit holes under the liner had been repaired, two coats of Belzona 5892 were applied to the first two hot liquor tanks using Belzona Know How System Leaflet TCC-5. Belzona 5892 was cured with hot water and washed down twice.
