BELZONA PREVENTS WATER PENETRATION INTO A DATA STORAGE FACILITY

ID: 7786

Application: FPA-Floor Problem Areas

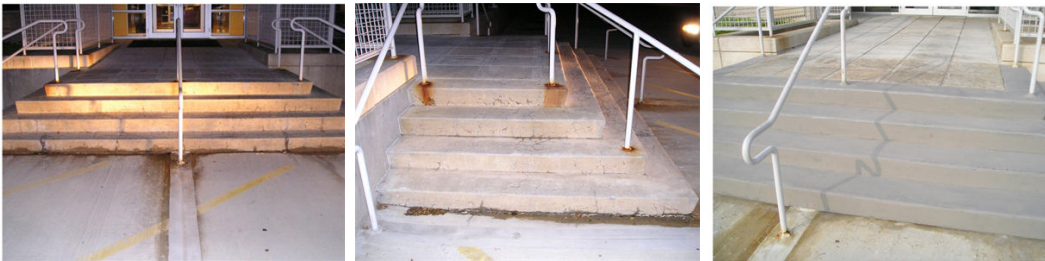
Photograph Descriptions

Spider cracks compromising the integrity of the staircase and allowing water to penetrate into the building's data center underground.

* Showing Damage After powerwashing Completed application; the cracks filled, and the steps re-surfaced with Belzona 4111 for a long-term protection ,

The entire repair was complete on a Saturday afternoon after employees vacated the building. The cracks were filled with Belzona 4111 and the entire surface was restored for waterproofing and a long-lasting protection.
