DATA CENTER'S RTU AND MAU REPAIRED AND PROTECTED WITH BELZONA

ID: 7787

Application: HEX-Heat Exchangers

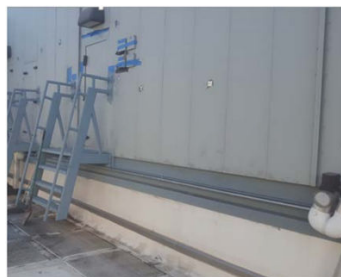
Corrosion and failing existing coating on steel infrastructure, disbanding of a sump "bedliner" coating system, controls room having excessive condensation. Although specified to have R-20 insulation value, the units only had R-6 insulation value when installed.

* Showing damage on steel structure Steel structures repaired and protected with Belzona 5111 and Belzona 6111 Cooling tower sump seams repaired with Belzona 3121 and protected with Belzona 5811 Insulation installed and encapsulated with Belzona 3111 ,

The steel structure was clean blasted to remove the loose and damaged particles. Achieving a white metal finish with a 3-5 mil profile. The surface was rebuilt where needed and coated with Belzona 5111 and 6111. The cooling tower sumps were first cleaned by removing the "bedliner", the surface was then abrasive blasted. The leaks were repaired with Belzona 1121. The seams were sealed with Belzona 3121 and the entire surface was then coated with Belzona 5811 to provide a cohesive chemical and water-resistant coating. R-20 insulation was installed and encapsulated with Belzona 3111.
