# BELZONA SEALS LEAKING WELDS IN FUEL TANK

ID: 779

Customer Location: *Cruise Ship, Florida.*  
Application Date: *April 2006*

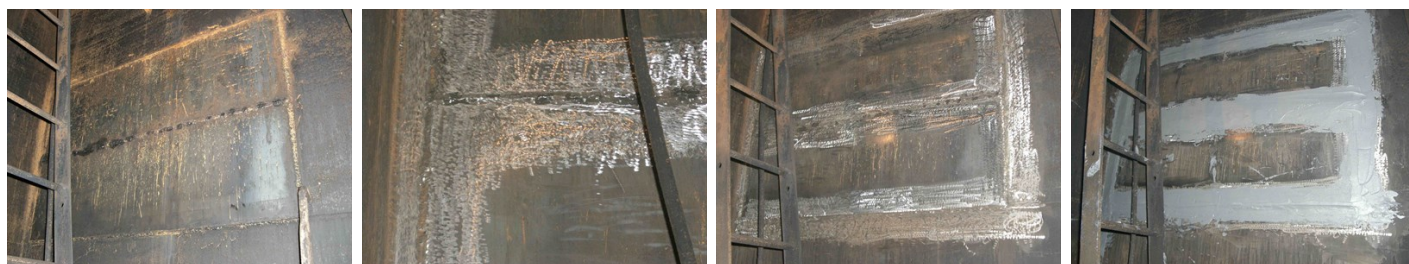
- \* Previous dry dock weld of doubler plates ,
- \* Perforated welds ,
- \* Roughened and degreased ,
- \* Welds sealed allowing ship to sail on time ,

Heated Diesel Tank (steam heated to 160°F). Welded doubler plates were found to be perforated and leaking post dry dock.

Application was carried out in accordance with Belzona Know-How System Leaflet TCC-1. After verifying gas free, surfaces ground, sweated and degreased to an acceptable white rag test.
