BELZONA SEALS LEAKING WELDS IN FUEL TANK

ID: 779

Customer Location: *Cruise Ship, Florida.*

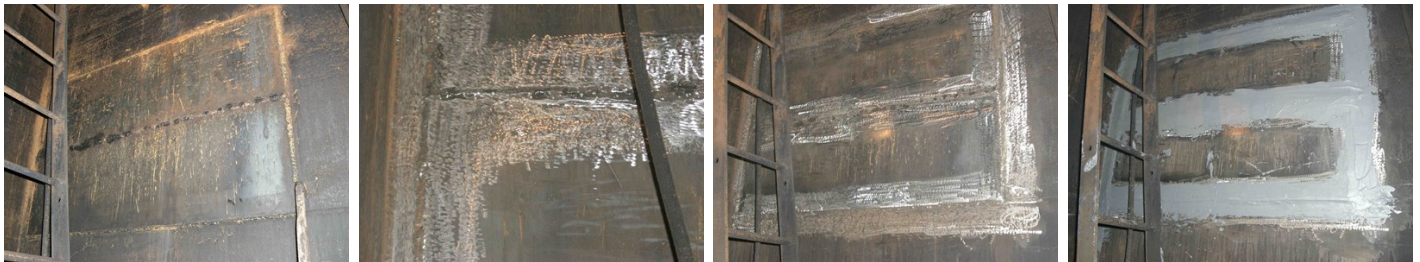
Photograph Descriptions

- * Previous dry dock weld of doubler plates ,
- * Perforated welds ,
- * Roughened and degreased ,
- * Welds sealed allowing ship to sail on time ,

Heated Diesel Tank (steam heated to 160°F). Welded doubler plates were found to be perforated and leaking post dry dock.

Application was carried out in accordance with Belzona Know-How System Leaflet TCC-1. After verifying gas free, surfaces ground, sweated and degreased to an acceptable white rag test.

Application completed in short day to meet the ships tight schedule which was prime concern.
