Propeller Shaft Protected with Belzona Coatings

ID: 7791

Marine vessel propeller shaft.

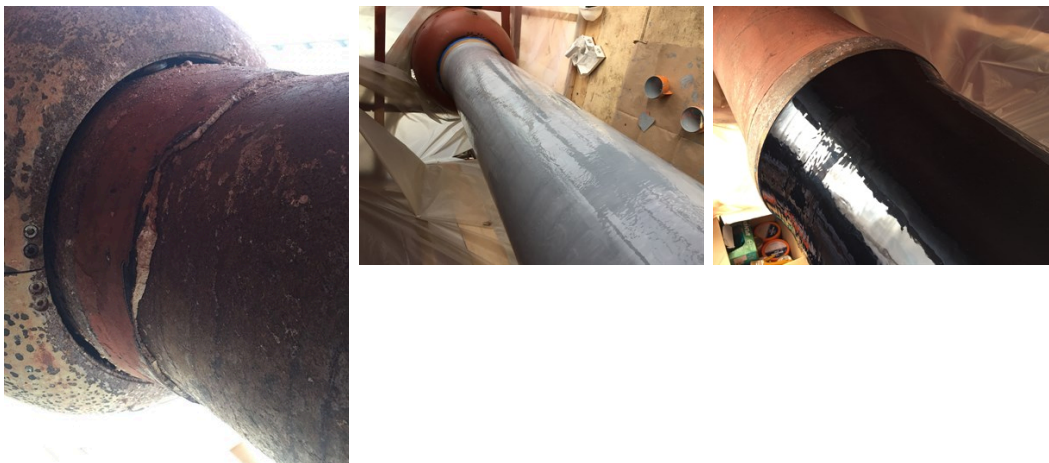
Previous coating had failed by delamination, causing the shaft body to corrode.

- * The failed coating and corroded shaft. ,
- * Shaft protected with Belzona 1341. ,
- * The finished job with the Belzona elastomer coating. ,

Application was carried out in accordance with a modified version of Belzona Know-How System Leaflet SOS-6.

As previous coating system had failed, the Customer was looking for a long-term protective solution. Belzona 1341 and Belzona 2141 system protected this vessel's propeller shaft long into the future.
