# Cooling Water Outlet Protected with Belzona 1321

Industry: Power  
Application: VPF-Valves, Pipes and Fittings  
Substrate: Mild steel  
Products: \* Belzona 1321 (Ceramic S-Metal) ,

Customer Location: Ireland  
Application Date: September 2018

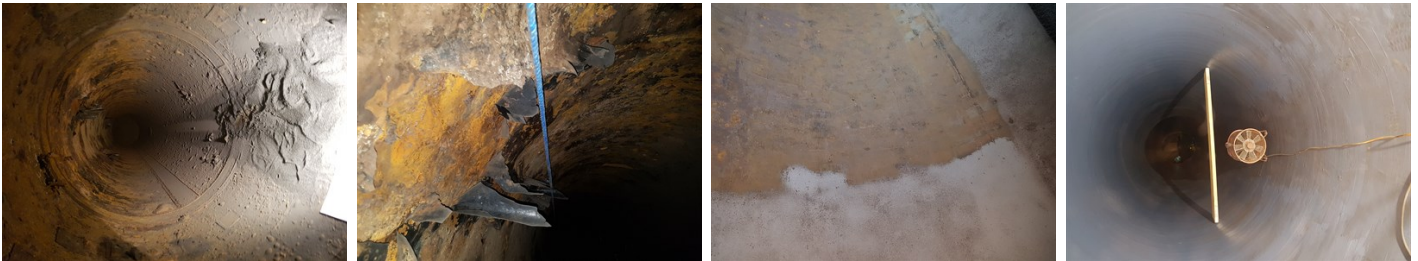
*The existing rubber lining had reached its end of life. The existing rubber was no longer providing the steel pipes with protection from erosion/corrosion. The rubber needed to be removed to allow for application of Belzona 1321.*

- \* Rubber lining in outlet pipe ,
- \* Condition of rubber lining ,
- \* Blasting in progress ,
- \* Finished Belzona 1321 ,

The rubber was stripped. The steel was grit blasted and then washed to removed all salts. The steel was blasted back to ISO 8501 SA 2 1/2 and Belzona 1321 was applied in two coats.
