Agitator Protected From Acid Attack by Belzona

ID: 7795

Customer Location: *Andalucia, Spain*
Application Date: *October 2018*

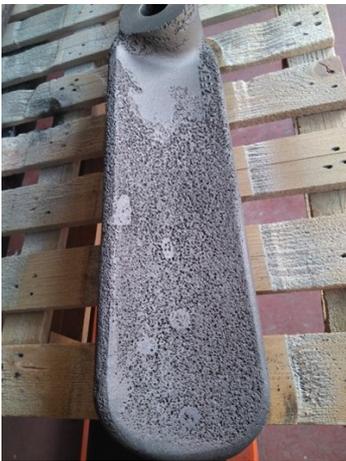
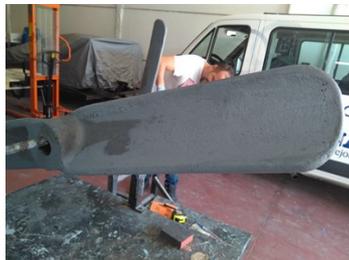
Concentrated sulfuric acid at elevated temperatures was causing deterioration of the agitator blades, which were being replaced every 4 months as a result.

- * 1. Damage to Blades ,
- * 2. Rebuilt with Belzona 1511 ,
- * 3. First coat applied ,
- * 4. Completed application ,

Agitator blades exposed to chemical attack and erosion in copper plant.

Application was carried out in accordance using a modified version of System Leaflet FBC-2.

fluid. They had tried a rubber coating to protect the blades, however the poor chemical resistance to the acid and temperature caused the rubber lining to fail quickly. It was concluded that erosion may not be the main cause of the damage, hence the customer wanted to trial a chemical resistant lining. As the conditions are 40% Sulfuric Acid at 80degC, Belzona 4341 is the best choice. An aggregate was incorporated into the coating to add some erosion resistance.
