Agitator Protected From Acid Attack by Belzona

ID: 7795

Customer Location: *Andalucia, Spain*
Application Date: *October 2018*

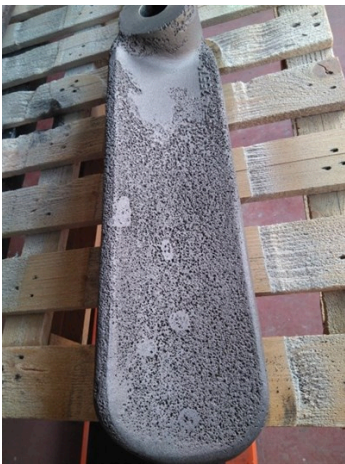
Concentrated sulfuric acid at elevated temperatures was causing deterioration of the agitator blades, which were being replaced every 4 months as a result.

- * 1. Damage to Blades ,
- * 2. Rebuilt with Belzona 1511 ,
- * 3. First coat applied ,
- * 4. Completed application ,
