Agitator Protected From Acid Attack by Belzona

ID: 7795

Agitator blades exposed to chemical attack and erosion in copper plant.

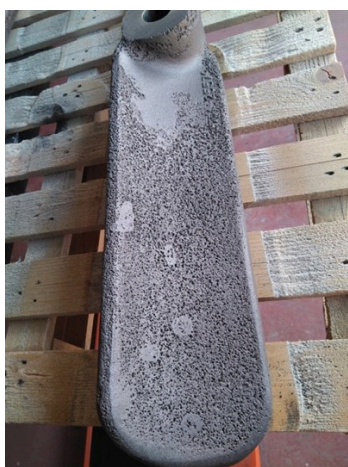
Concentrated sulfuric acid at elevated temperatures was causing deterioration of the agitator blades, which were being replaced every 4 months as a result.

- * 1. Damage to Blades ,
- * 2. Rebuilt with Belzona 1511 ,
- * 3. First coat applied ,
- * 4. Completed application ,
