Nuclear HEX Refurbished with Belzona

Industry: Power
 Application: HEX-Heat Exchangers
 Substrate: Carbon Steel
 Products: * Belzona 1511 (Super HT-Metal),
 * Belzona 1391T,

Customer Location: Slovenia
 Application Date: October 2016

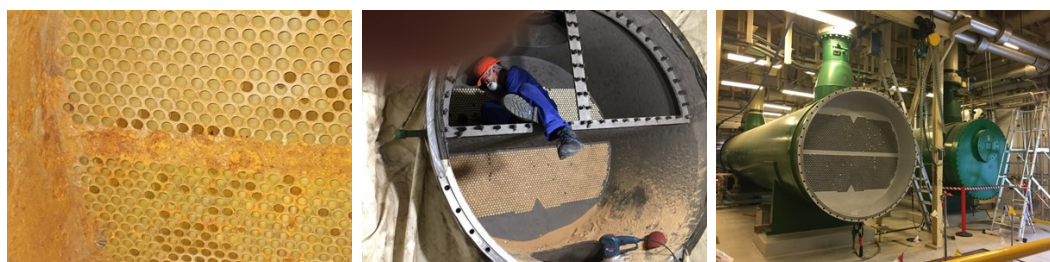
Photograph Descriptions

River water used for the cooling system had cause corrosion and pitting on the tube sheet of a heat exchanger.

- * 1.) Corroded Tube Sheet ,
- * 2.) Rebuilding with Belzona 1511 in progress ,
- * 3.) Repairs completed with Belzona 1391T ,
- * 4.) Close up of HEX after 18 months in service, still in perfect condition ,

The application was carried out in accordance with Belzona System Leaflet HEX-01.

Replacement was the only alternative to the repairs, however this is very costly. Due to very high cost of downtime, the application had to be carried out within a short window. The local Belzona Distributor was able to offer a speedy repair due to their many years of application experience. The application required careful planning and a larger than normal work force. Only when the customer was satisfied that the application could be carried out within the time window were they convinced to proceed with the application instead of ordering a replacement. Heat exchanger inspected after 18 months of being service and still shown to be in perfect condition.
