# Belzona Repairs and Protects the Floor of a Battery Treatment Plant

**Industry:** General Industry  
**Application:** FPA-Floor Problem Areas  
**Substrate:** Concrete  
**Products:** \* Belzona 4151 (Magma-Quartz Resin) ,  
\* Belzona 4311 (Magma CR1) ,

**Customer Location:** Chemical Plant, France  
**Application Date:** October 2018

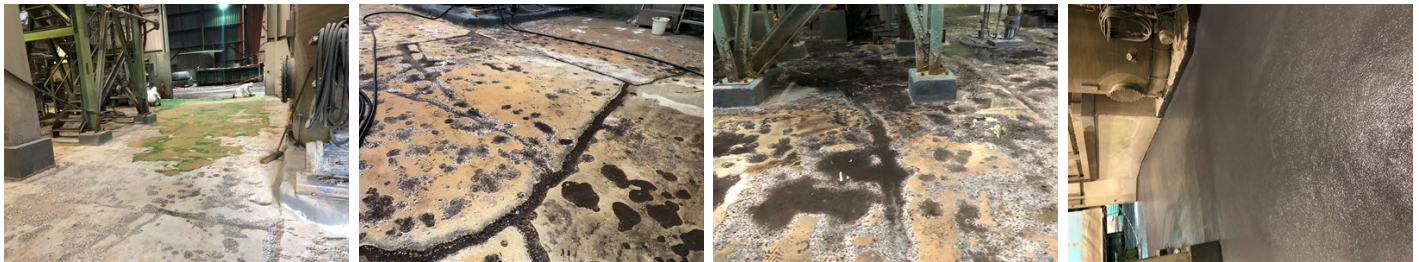
*The concrete floor of this battery treatment plant was badly damaged by the acid from the batteries. Around 400 tonnes of batteries are treated each day in this plant and the acid attacked the concrete leading to severe pitting up to 40cm deep.*

- \* Before application. ,
- \* Before application. ,
- \* After resurfacing with Belzona 4151. ,
- \* Final application after protection with Belzona 4311. ,

The floor was first washed and the surface roughened. Then Belzona 4151 was used with silica sand to resurface the whole area and repair the pitting due to the attack of the acid. Finally, Belzona 4311 was used to protect the floor against further damage from the acid. This was completed in accordance with Belzona Know-How System Leaflet FPA-03.
