# Belzona Protects Washing Powder Hoppers

ID: 7800

Application: TCC-Tanks and Chemical Containment Areas

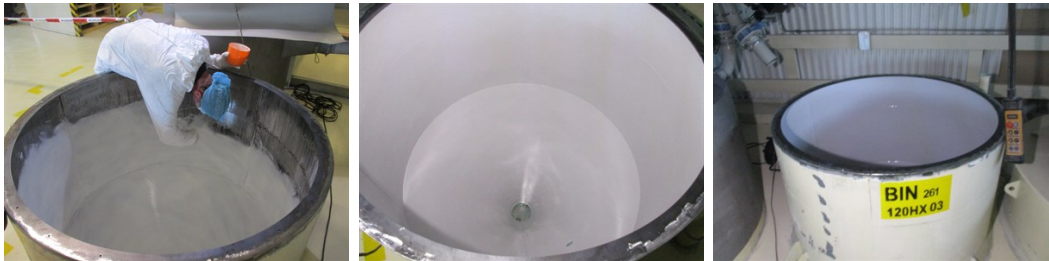
*The citric acid content of the washing powder was causing erosion-corrosion to the supply hoppers*

- \* Application in progress, showing the unprotected substrate ,
- \* Closeup of the finished coating ,
- \* The equipment at hand ,

The application was carried out in accordance with Belzona System Leaflet TCC-3. Belzona 1331 was applied by brush.

A Belzona coating was chosen as the Customer sought after a long-term corrosion protection against citric acid, whilst also having the durability to withstand dry abrasion from powder.
