Belzona Seals Process Tower Roof

ID: 7801

Customer Location: Fertiliser Plant, France
Application Date: October 2018

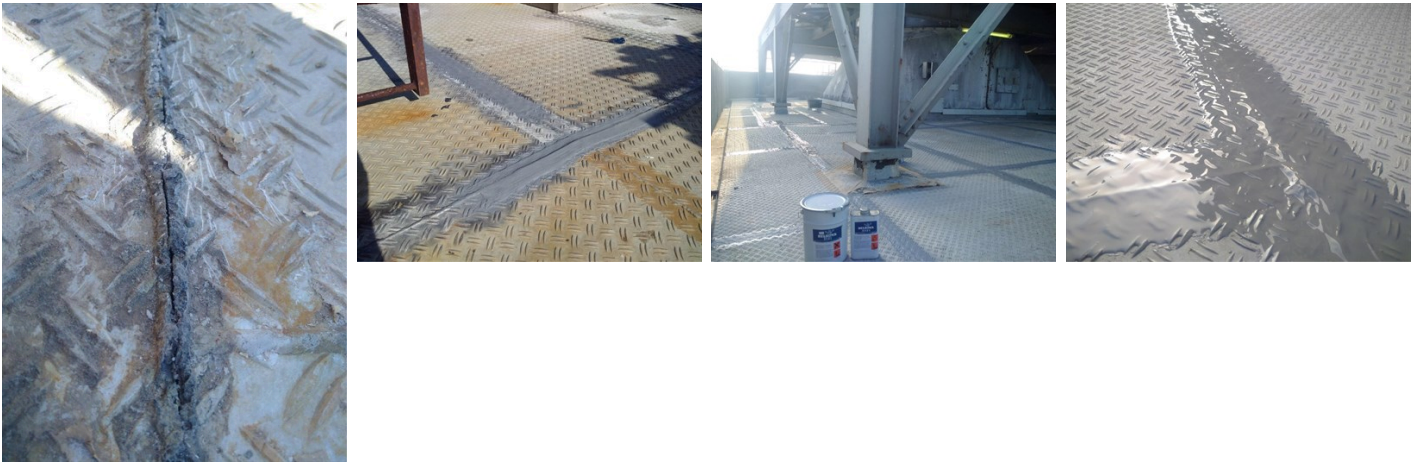
The roof of a process tower in this fertiliser plant was leaking due to the chemicals that were attacking the welds. Infiltration of water was becoming problematic for the production and the roof had to be fixed.

- * Before application ,
- * Sealing step with paste grades ,
- * Final application ,
- * Sealing close up ,

The previous repairs were removed and Belzona 1111, 1161, 1212 and 9341 (reinforcement sheet) were used to seal the gaps. Then two coats of Belzona 3121 were applied on top of the repairs to seal in accordance with Belzona KNow-How System Leaflet RPA-1.

The other classic sealing methods with silicon or resin did not withstand the conditions. Welding was not allowed on site because of the presence of chemicals, and would still leave the area prone to corrosion. The fact that the whole application could be carried out without any hot work was a great advantage for the customer.
