Belzona Repairs and Protects a Corroded Feeding Pipe

Customer Location: Petrochemical Plant, France
Application Date: November 2018

Emergency repair on a feeding pipe circulating sulphuric acid into a storage tank.

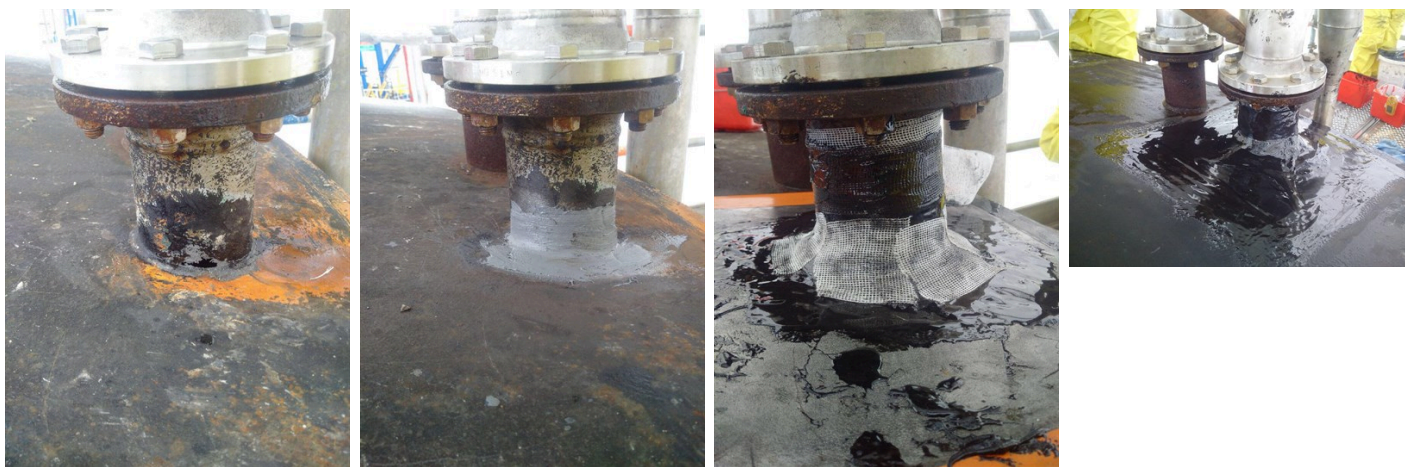
The pipe was perforated due to corrosion and sulphuric acid was leaking out.

- * Before application. ,
- * After Belzona 1212 to plug the leak. ,
- * Belzona 4341 applied with reinforcement sheets. ,
- * Final application. ,

The leak was plugged with Belzona 1212 in order to secure the pipe. The surface was then manually prepared and Belzona 4341 was used with a reinforcement sheet all around the pipe to reinforce its structure and protect it against acid, in accordance with Belzona system leaflet VPF-11.
