Blast Furnace Gas Leak Pipe Repair

ID: 7814

Industry: Steel & Metal Processing

Customer Location: Czech Republic

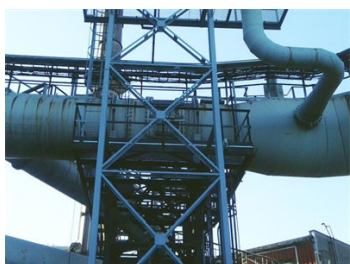
Steel plant blast furnace gas inlet had developed a leak and was losing pressure. The repair needed to be done whilst equipment was online.

- * The blast furnace gas inlet. ,
- * The repair is underway. ,
- * The finished repair. ,
