# Belzona Repairs and Protects a Sand Filter in a Swimming Pool

ID: 7815

Application Date: November 2018

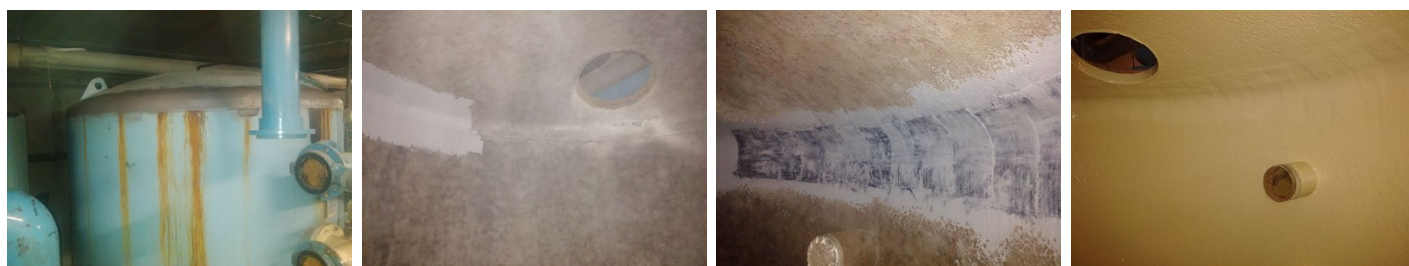
The inside of this sand filter in a swimming pool was badly damaged by corrosion and chemical attacks, especially chloride. After grit blasting the substrate, through-wall defects were found.

- \* Before application. ,
- \* Repair using Belzona 1111. ,
- \* Application after using Belzona SuperWrap II. ,
- \* Final application. ,

The substrate was first prepared by grit blasting, then the pitting was repaired with Belzona 1111. On top of this repair, Belzona SuperWrap reinforcement sheets impregnated with Belzona 1981 resin were applied to restore the structural strength of the filter. Finally, Belzona 5811 was applied on the whole surface inside the tank after a surface preparation of the Belzona SuperWrap using an MBX.
