Belzona Repairs Damaged Feet of a Pulper

ID: 7817

Customer Location: Paper Mill, France
Application Date: August 2008

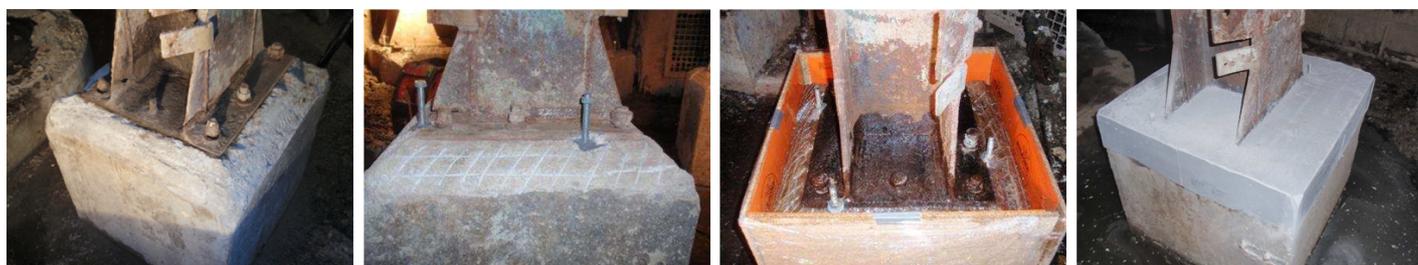
Photograph Descriptions

The five feet of a paper mill pulper and the concrete blocks underneath were badly damaged. The bolts keeping the feet in place on the concrete blocks were badly corroded. The whole equipment was no longer resting safely on the concrete base.

- * Before application ,
- * Threaded rods bonded with Belzona 1111 after surface preparation ,
- * Conditioner and former installed ,
- * Completed Application ,

The whole surface that needed to be repaired was high-pressure washed, then a needle gun was used to get rid of the rust and the metallic parts were roughened with a metallic brush. The needle gun and a diamond disk were also used to prepare the concrete and ensure a good mechanical adhesion. Belzona 1111 was then used to bond threaded rods to keep the feet in place and enhance the adhesion of Belzona 4111, in accordance with Belzona System Leaflet GSS-08. Belzona 4911 was then used on the whole surface and a former was placed all around the concrete blocks. Belzona 4111 was poured into the former in several packed layers, and once cured, the former was taken off.
