# No More Leaks on a Cooling Tower with Belzona

ID: 7820

Water pipe on a cooling tower.

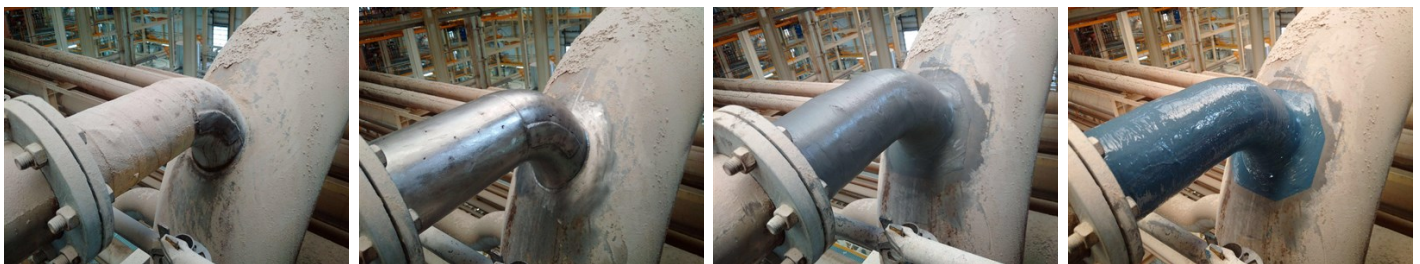
*This water pipe was leaking due to antibacterial agents present in the water damaging the substrate and causing corrosion pitting.*

- \* Before application ,
- \* After surface preparation ,
- \* After application of Belzona 1111 with reinforcement tape ,
- \* Final application ,

The pipe was manually prepared using an MBX and degreased with Belzona 9111. The pipe was then consolidated using Belzona 1111 and 9341 (3 passes). Belzona 1321 was finally used on top of the repair to avoid any porosity and give a good smooth finish.
