# Belzona saves Ruptured Effluent Tank

ID: 7821

**Industry:** Food & Drink  
**Application:** VPF-Valves, Pipes and Fittings  
**Substrate:** Glass reinforced steel  
**Products:** \* Belzona 9611 ES Metal Stick ,  
\* Belzona Superwrap II plates ,  
\* Belzona 1212 ,

**Customer Location:** England, UK  
**Application Date:** October 2018

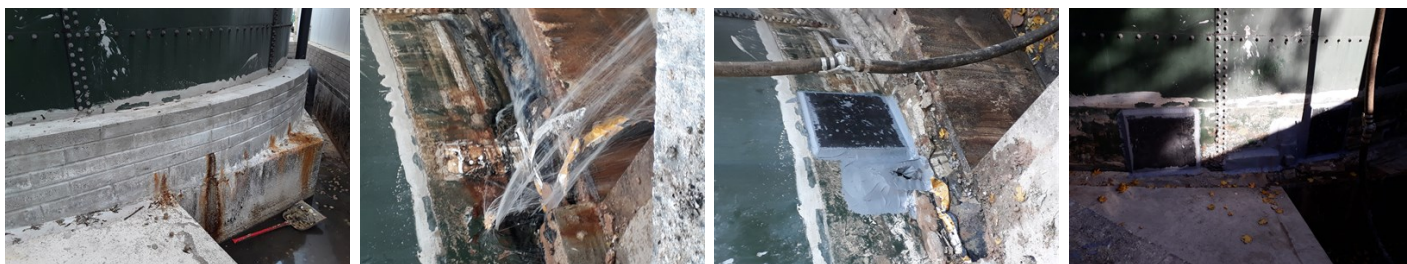
The problem that the customer had was that the effluent treatment tank had multiple leaks, both into the surrounding soil, and into a bund. To avoid both hefty fines and a full tank failure, they had to find a way to repair the tank but without hindering their production. This grave situation was compounded by the fact that the tank was set on a hill within the production facility premises, but about 100 metres overlooking a large retail park. Should the tank have had a catastrophic failure when we removed the wall, 200+ tons of food waste effluent would have poured into the shopping centre, effectively shutting the whole area down.

- \* 1: Before the wall came down ,
- \* 2: The ruptured area ,
- \* 3: SWII plates bonded in place ,
- \* 4: Finished application ,

First all the holes and cracks were plugged with wooden wedges to stem the flow. Then the areas around them were patched with Belzona 9611. Applied in accordance with a modified version of Belzona Know-How System Leaflet VPF-11. As this cured, another piece was placed over this piece, moving slowly around the splits and holes until they became virtually sealed. The wooden wedges were then sawed off as close to the tank as possible. Next, a manufactured "top-hat" was drilled and tapped, and bonded over one of the entire failed areas with Belzona 1111, encompassing all the splits and leaks in that area. The tapped "top-hat" meant that

the small leaks had a means of escape whilst the Belzona 1111 was curing. Finally, when the Belzona 1111 cured a bolt was screwed in, sealing the leaks. An area to the right of the “top-hat” was patched using a large sheet of Belzona Superwrap II. Finally, Belzona 1111 was applied as a 75mm band around the base of the tank, incorporating reinforcement sheets, to seal the multiple leaks around the base.
