# Wood Particles Drum Repaired with Belzona

Application: *SHM-Solids Handling Machinery*

Products: *\* Belzona 1812 (Ceramic Carbide FP) ,*

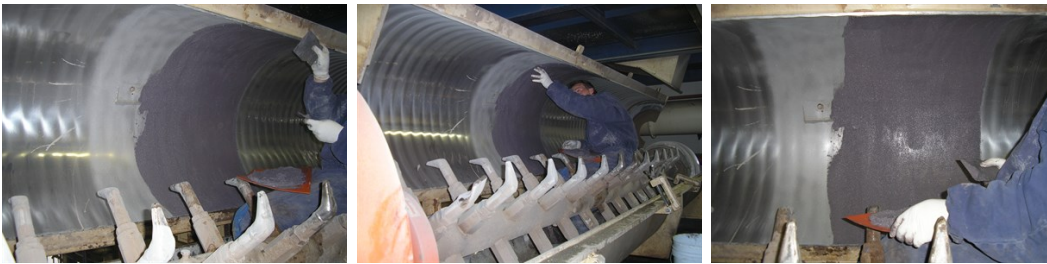
## Photograph Descriptions

*The glue and wood particles mixture was very abrasive and the after a short period of time, there was localised damage to the drum.*

- \* Surface after blasting - ready for repair ,
- \* Belzona 1812 local application ,
- \* Perfect protection against abrasive mixture ,

Application was carried out using Know-How System Leaflet SHM-13

The only alternative to the Belzona solution was to replace all of the drums with new ones, as welding was difficult and time consuming. Also, replacing would have been very expensive and time consuming. The Belzona solution solved these problems that the customer had faced.
