Wood Particles Drum Repaired with Belzona

ID: 7824

Application: SHM-Solids Handling Machinery

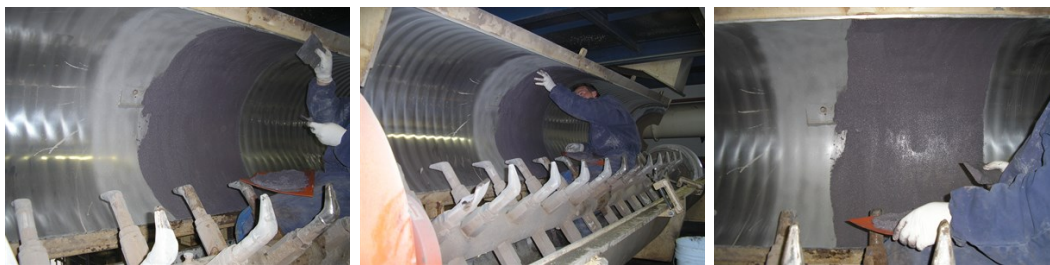
Photograph Descriptions

The glue and wood particles mixture was very abrasive and the after a short period of time, there was localised damage to the drum.

- * Surface after blasting - ready for repair ,
- * Belzona 1812 local application ,
- * Perfect protection against abrasive mixture ,

Application was carried out using Know-How System Leaflet SHM-13

The only alternative to the Belzona solution was to replace all of the drums with new ones, as welding was difficult and time consuming. Also, replacing would have been very expensive and time consuming. The Belzona solution solved these problems that the customer had faced.
