# Pipe adapter repaired by Belzona

ID: 7825

Application: *SHM-Solids Handling Machinery*

Customer Location: *Maize starch producer in Slovakia*

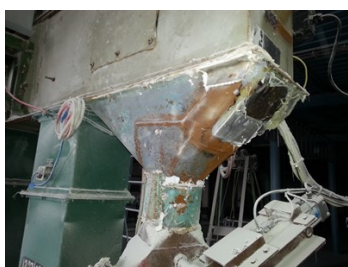
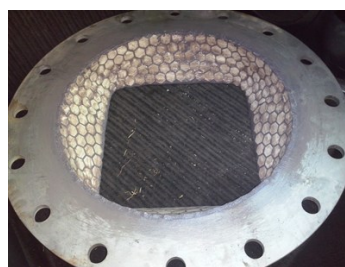
*Maize kernels transport is very abrasive. This product is able to damage some parts of the pipe system in 6 months.*

- \* Pipe system for maize kernels transportation ,
- \* Pipe adaptor in system ,
- \* Perfect protection against abrasive maize kernels ,
- \* Detail of the finished repair ,

Application was carried out using Know-How System Leaflet SHM-13 with Belzona 9811.

Customer used to change some parts of pipe system before Belzona protection, but it was expensive and after 6 months was in the same situation. Then they tried to weld some steel protection against abrasion, but result was the same. Belzona solution solved these customer problems and they are satisfied with it.
