# Belzona Shaft Repair By Forming Technique at a Paper Mill

ID: 7835

Shaft on a vacuum pump at a paper mill.

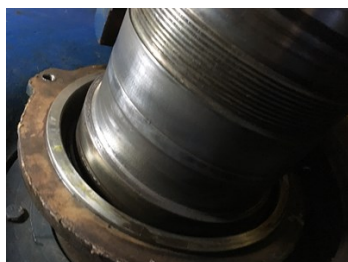
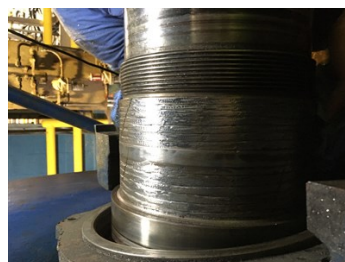
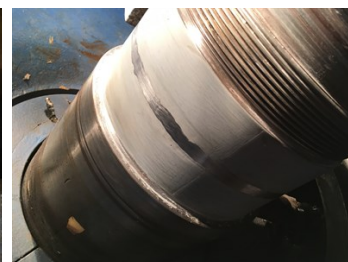
*Bearings spun on shaft taking with it an estimated .080 or 80 thousandths from the shaft.*

\* Former that was made and used. <br /> Damaged shaft. <br /> Shaft prepared/surface roughened up. <br /> Finished application. ,

This application was carried out in accordance with a modified version of Belzona Know-How System Leaflet MPT-2 (Shaft Repair by Forming Technique). The area was prepared by using a small disk grinder which was used to cut grooves into the shaft then was roughened by using a bur bit. The shaft was thoroughly cleaned using Belzona 9111. Belzona 9411 was placed on the former and on the shaft where product was not wanted. Belzona 1111 was placed on the shaft and on the former and squeezed together. After a few hours the former was removed and the shaft was dressed up making sure to remove any unwanted Belzona 1111.
