# Belzona Shaft Repair By Forming Technique at a Paper Mill

ID: 7835

Application: MPT-Mechanical Power Transmission

Shaft on a vacuum pump at a paper mill.

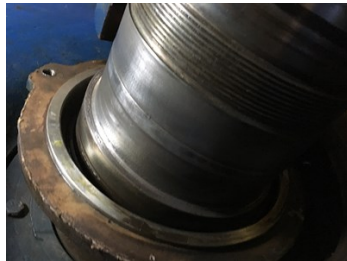
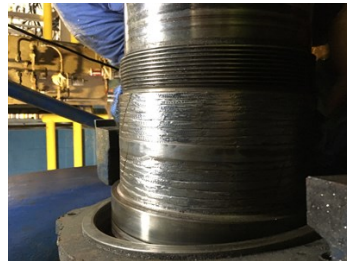
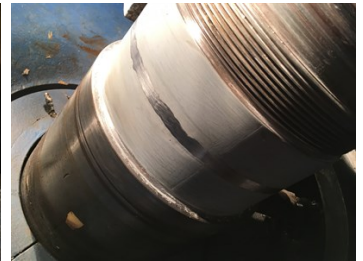
Bearings spun on shaft taking with it an estimated .080 or 80 thousandths from the shaft.

\* Former that was made and used. Damaged shaft. Shaft prepared/surface roughened up. Finished application. ,

This application was carried out in accordance with a modified version of Belzona Know-How System Leaflet MPT-2 (Shaft Repair by Forming Technique). The area was prepared by using a small disk grinder which was used to cut grooves into the shaft then was roughened by using a bur bit. The shaft was thoroughly cleaned using Belzona 9111. Belzona 9411 was placed on the former and on the shaft where product was not wanted. Belzona 1111 was placed on the shaft and on the former and squeezed together. After a few hours the former was removed and the shaft was dressed up making sure to remove any unwanted Belzona 1111.
