BELZONA SPHERE LINING ROLLED OUT

ID: 7847

Industry: Oil & Gas
Application: VPF-Valves, Pipes and Fittings
Substrate: Carbon steel
Products: * Belzona 1111 (Super Metal) ,
* Belzona 4311 (Magma CR1) ,

Customer Location: Oil & Gas Production, UK
Application Date: 2010 - 2018

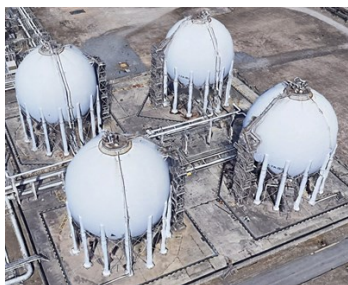
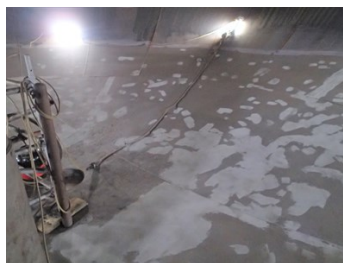
Belzona was first approached in 2009 for a lining that would be resistant to the unstabilised crude oil and sulphur reducing bacteria. The affected area was in the tank belly, up to a height of 3.5m. These areas included many manways and narrow nozzles, which also needed protection. With limited application time, a lining was needed that could also be sprayed over the 290m² for each vessel.

- * Storage spheres from the air. ,
- * Plan of coating height. ,
- * Lowest section filled with Belzona 1111. ,
- * Lowest section completed with Belzona 4311. ,

Internal corrosion in belly of these 24m diameter spheres was becoming a serious concern and was being accelerated by microbial attack.

Prequalification trials proved the Belzona 4311 could be sprayed using plural feed equipment and the first sphere was coated in 2010, in accordance with a modified version of Belzona Know-How System Leaflet TCC-5. Small bore nozzle inserts were installed using a modified version of Belzona Know-How System Leaflet TCC-16a.

The application was a complete success, and in the following years the solution was rolled out to the other spheres on the site. The final sphere was coated with the new generation Belzona 4311 in 2018, which made the application much easier. In addition,
