Belzona Elastomer Solution Filters Out the Competition

Industry: Power
Application: TCC-Tanks and Chemical Containment Areas
Substrate: Steel
Products: * Belzona 1331 ,

Customer Location: Qatar
Application Date: January 2015 - Ongoing

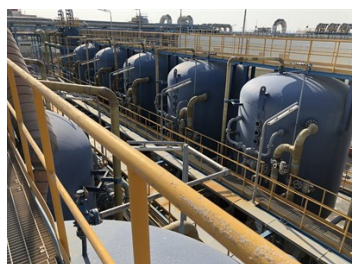
- * Limestone filters at the Power Plant. ,
- * Alternative rubber lining disbonded during a trial phase. ,
- * Alternative protective coating blistered during a trial phase. ,
- * Belzona 1331 - No traces of failure after 8-month trial period. ,

15-year-old limestone filter at a power plant.

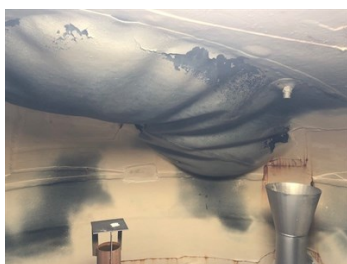
The rubber lining for a 15-year-old limestone filter was suffering from severe disbondment and failure. In fact, it was unable to sustain the operation of filtering water on a daily basis due to aggressive erosion.

The client chose to compare three systems simultaneously, over an eight-month period, to assess their performance. The systems selected were: 1. bonding of a rubber lining; 2. using a competitor ceramic coating; 3. using Belzona 1331. The existing rubber lining was removed back to a bare metal substrate before water washing the substrate and blasting to SA 2.5 cleanliness. Subsequently, three coats were applied at 500 microns in accordance with a modified version of Belzona Know-How System Leaflet TCC-3.
