Chimney restored with Belzona

ID: 7856

Customer Location: Baltic region, Poland
Application Date: 2018

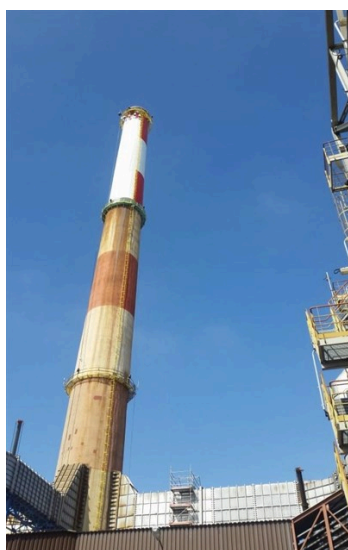
The 120-meter high chimney of the plant's combined heat and power plants required a new more durable coating protection. Previous coatings were very quickly tarnished and damaged.

- * The deteriorated chimney ,
- * The application underway ,
- * The completed job ,
- * The completed job ,

The application was carried out in Accordance with Belzona System Leaflet FBC-02 The chimney was cleaned, the old paint was removed by abrasive blasting to achieve a good surface profile. Then, Belzona 5911 Ceramic Cladding Conditioner was applied. Two layers of Belzona 5111 (Ceramic Cladding) coating were then applied onto a conditioned surface. The total area to be covered was 4,000 square meters.
