# Belzona repairs the suction part of a hydro turbine

Suction part of a hydro turbine from a hydroelectric plant

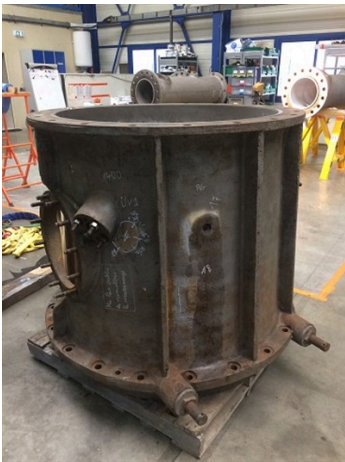
*The internal surface of this hydro turbine presented an important loss of metal which ultimately led to a hole.*

- \* 1- Before application ,
- \* 2- After grit blasting ,
- \* 3- Application of Belzona 1311 ,
- \* 4- After application ,
