# Belzona repairs and protects a Sand filter at a Nuclear Power Plant

Sand filter in a Nuclear power plant

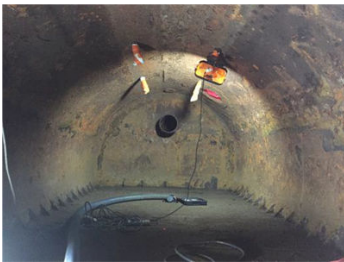
*Internal corrosion*

- \* 1- Before application ,
- \* 2- Surface aspect before surface preparation ,
- \* 3- After surface preparation ,
- \* 4- After application ,

The application was carried out in accordance with Belzona Know How System Leaflet TCC-5. After grit blasting the substrate, it was degreased and the pitting was repaired with Belzona 1111. The surface was then protected with Belzona 1321 to prevent any future corrosion.
