Belzona Repairs Ball Mill Foundations at a Gold Mine

Application: *FPA-Floor Problem Areas*

Concrete ball mill foundations.

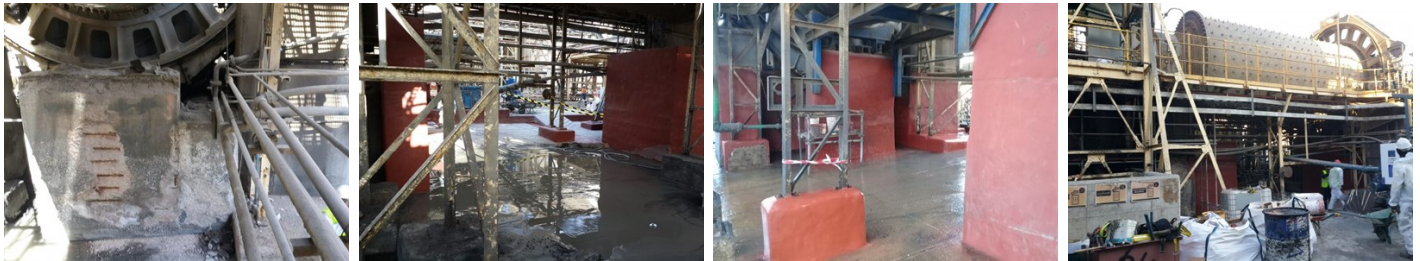
Photograph Descriptions

The concrete ball mill foundations degraded over time due to vibrations and warm environment.

- * Before application ,
- * During the application ,
- * Final application ,
- * Overview of the equipment ,

The substrate was first prepared by grit blasting prior to the installation of steel reinforcement bars. Belzona 4911 was then applied on the whole surface followed by Belzona 4131. The application was carried out in accordance with a modified version of Belzona Know-How System Leaflets FPA-1 and FPA-3.
