# BELZONA BONDS NEW BRACKETS TO TANK ROOF

ID: 7866

**Customer Location:** Petrochemical Plant, Netherlands  
**Application Date:** September 2018

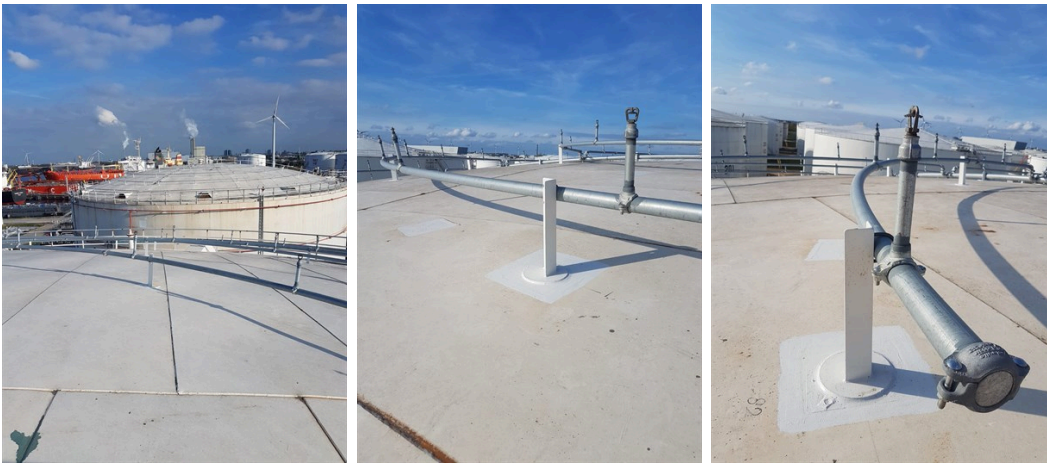
- \* 1- Overview of the tank roof ,
- \* 2- Final application ,
- \* 3- Zoom on a cold bonded bracket ,

For each tank, the substrate was prepared with a dust free blasting system in order to achieve the right surface roughness without generating dust and potential fire hazards near the oil. Then, the brackets were bonded using Belzona 1111. Over 1000 brackets/support were bonded over 7-8 different storage tanks. 8 brackets were bonded on the side of a few tanks, the remaining brackets were bonded on the top of the tanks. The vertical brackets were help in place using magnets and vice mechanisms, while the brackets on the roof were bonded without additional weight or pressure during the curing process.
