# BELZONA SAVES TANK FROM DEMOLITION

ID: 7867

**Industry:** Power  
**Application:** VPF-Valves, Pipes and Fittings  
**Substrate:** Carbon steel, concrete  
**Products:** \* BELZONA 4111 (Magma-Quartz) ,  
\* BELZONA 3111 (Flexible Membrane) ,  
\* BELZONA 3412 (Encapsulating Membrane) ,

**Customer Location:** North West England  
**Application Date:** December 2018

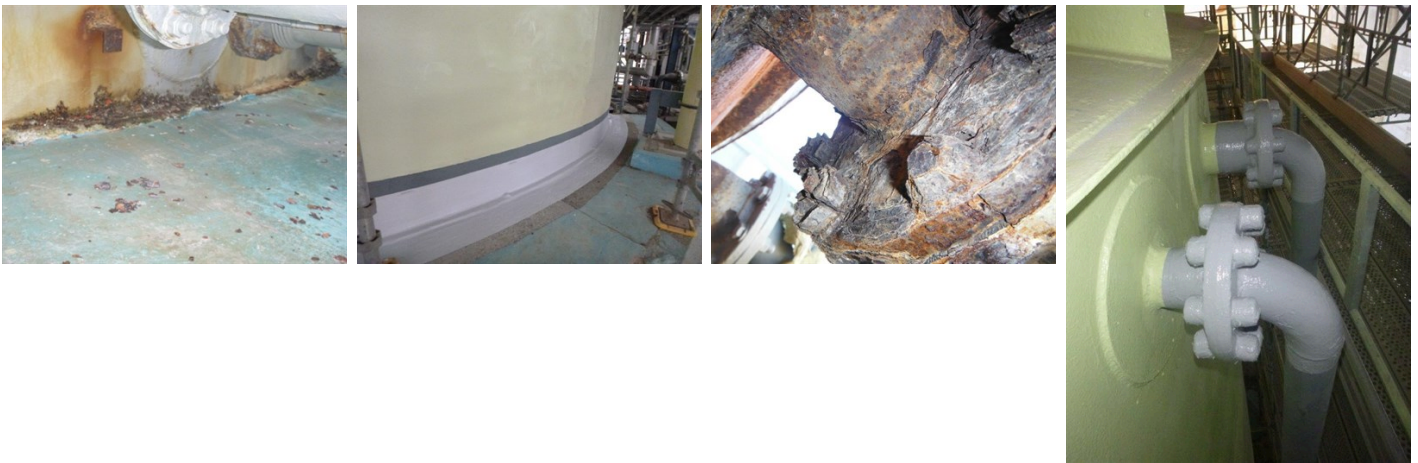
## Photograph Descriptions

Tank has badly corroded annular plate with suspect under thickness tank base plate due to atmospheric pollutants running down the tank walls and under the plate causing external corrosion. Also, the concrete plinth has cracked and has corrosion causing some spalling.

- \* 1. Condition of concrete plinth and tank base ,
- \* 2. Application of Belzona 3111 in grey ,
- \* 3. Corroded flanges ,
- \* 4. Application of Belzona 3412 (Encapsulating Membrane) ,

The concrete was cleaned. The cracks and defects were rebuilt with Belzona 4111 and Belzona 4911 system. The annular plate was sweep blasted and cleaned prior to applying Belzona 3111 around the tank base in accordance with a modified version of Belzona Know-How System Leaflet GSS-3.

The corroded pipe and flanges were removed and new ones were installed. The new flanges were then encapsulated with Belzona 3412 in accordance with a modified version of Belzona Know-How System Leaflet VPF-13.
