BELZONA SAVES TANK FROM DEMOLITION

ID: 7867

Customer Location: North West England
Application Date: December 2018

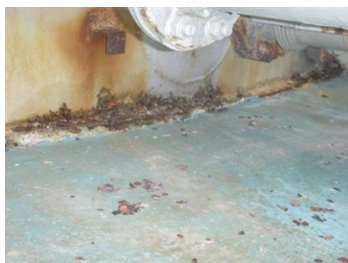
Tank has badly corroded annular plate with suspect under thickness tank base plate due to atmospheric pollutants running down the tank walls and under the plate causing external corrosion. Also, the concrete plinth has cracked and has corrosion causing some spalling.

- * 1. Condition of concrete plinth and tank base ,
- * 2. Application of Belzona 3111 in grey ,
- * 3. Corroded flanges ,
- * 4. Application of Belzona 3412 (Encapsulating Membrane) ,

The concrete was cleaned. The cracks and defects were rebuilt with Belzona 4111 and Belzona 4911 system. The annular plate was sweep blasted and cleaned prior to applying Belzona 3111 around the tank base in accordance with a modified version of Belzona Know-How System Leaflet GSS-3.
