Corroded Weighing Bridge Repaired and Protected

ID: 7870

Substrate: Carbon steel checker plate

Products: * Belzona 1111 (Super Metal) ,
* Belzona 5231 (SG Laminate) ,

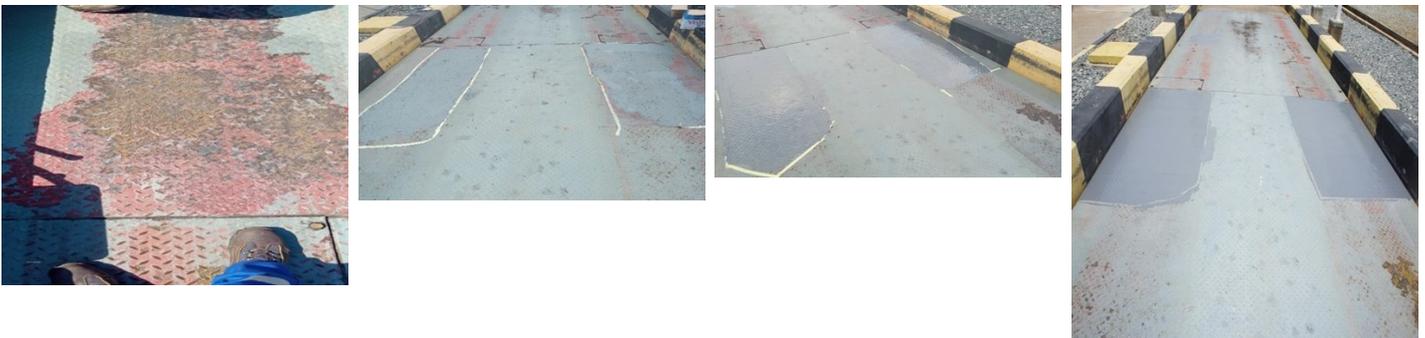
Photograph Descriptions

The Customer had an existing weighbridge to determine the amount of Liquefied Petroleum Gas (LPG) leaving the plant on trucks, the corroded weighbridge undermines the accuracy of the data derived from the weighbridge. The worn out surface of the weighbridge was also a safety issue, the Customer has used other surface protection products that failed within a very short period so they opted for Belzona solutions because of the proven durability.

- * Corroded surface of the weigh bridge Original weighbridge. ,
- * During application on the weighbridge checker plate. ,
- * Belzona 1111 being applied to rebuild lost metal. ,
- * Belzona 5231 being applied to prevent further wear and corrosion. ,

Application was carried out in accordance with a modified version of Belzona System Leaflet FPA-3 for protecting floors and drains against chemical attack. Belzona 1111 was applied to rebuild the lost metal after surface was blasted with Bristle Blaster. Belzona 5231 was then applied as a heavy-duty protective coating and to protect against further corrosion.
