# Dewatering Centrifuge Scroll Rebuilding and Protection with Belzona

Customer Location: Wastewater Treatment Plant, Riyadh,  
Saudi Arabia

A Dewatering Centrifuge Scroll

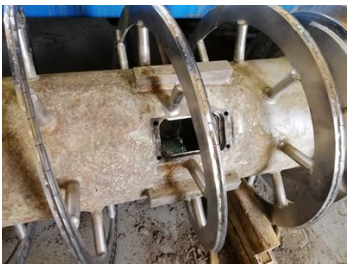
The Dewatering Centrifuge Scroll was damaged and metal chunks were broken due to aggressive wear and abrasion of waste material. All this lead to the client taking it out of service

- \* 1. The Dewatering Centrifuge Scroll ,
- \* 2. A close up of the damage ,
- \* 3. Rebuilt with Belzona 1311 ,

In accordance with CEP-1, firstly, the surface was prepared using A3 Grit to get a surface profile of minimum 75 microns. Then, solvent cleaning using MEK. After that, the damaged/abraded surface was filled with Belzona 1311 (Ceramic R-Metal) to level. Finally, Belzona 1812 (Ceramic Carbide) was applied as an abrasion resistant lining to a thickness of 3mm.
