Belzona® Repairs worn out fan shaft due to abrasion and bearing seizure

ID: 7875

Fan shaft

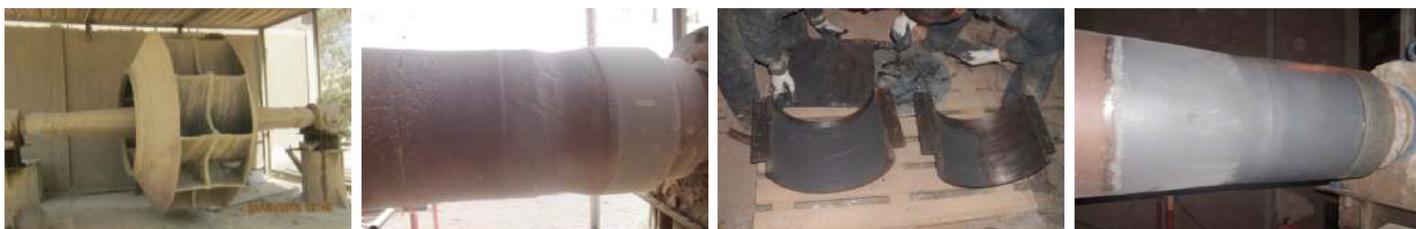
Photograph Descriptions

Deeply worn out due to abrasion in Fan shaft due to abrasion and bearing seizure.

- * 1. General view of the Fan shaft. ,
- * 2. Wear area in Fan shaft. ,
- * 3. Fabricated former to get the required dimensions. ,
- * 4. Application Done. ,

The application was carried out in accordance with Belzona Know-How System Leaflet MPT-2 for rebuilding damaged shafts using forming techniques. The area was prepared using a disk grinder to roughen the surface and to make a cross-hatching pattern on the surface. A coat of Belzona 9411 was applied to the inside of the formers, and the edges where material will be pushed out. Belzona 1111 was applied to the shaft and covered the entire area using a brush and the mixing spatula to apply the product. Also, the inside of the formers were covered and evenly spread. The formers were clamped to the shaft. Once Belzona 1111 had cured the former was removed.
