# Galvanic Corrosion on a Flange Solved by Belzona

ID: 7876

Application: VPF-Valves, Pipes and Fittings

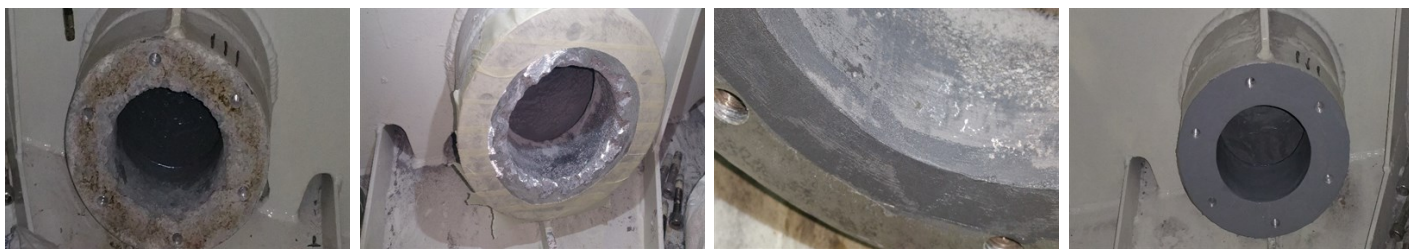
## Photograph Descriptions

Dissimilar metals were used for the flange connection, leading to galvanic corrosion.

- \* 1. Corroded flange. ,
- \* 2. Surface preparation complete. ,
- \* 3. Rebuilding with Belzona 1161. ,
- \* 4. Coated with Belzona 5831. ,

The application was carried out in accordance with a modified version of Belzona Know-How System Leaflet VPF-13.

The alternative options were to weld and machine back to the original surface, however this option was not chosen as it would not have solved the issue of galvanic corrosion. The second option was to replace the connecting flange using a part made from aluminium. However, this proved to be a costly option. The Belzona solution prevents galvanic corrosion and repairs the damage without the need to replace any parts, saving the customer time and money.
